Building Damage and Usability Assessment after earthquake (BDUA)

TECHNICAL MANUAL

TECHNICAL MANUAL
for the Building Damage and Usability Assessment (BDUA)
after earthquake

The **Technical Manual** is part of the technical framework to conduct and coordinate Building Damage and Usability Assessment (BDUA) services after an earthquake in Albania.

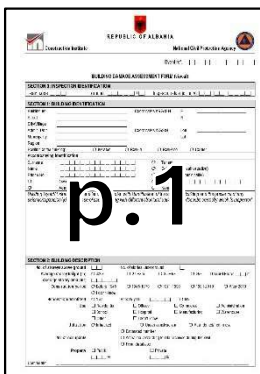
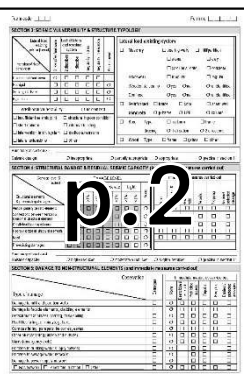
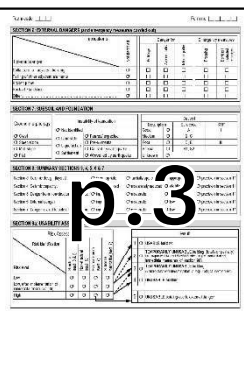
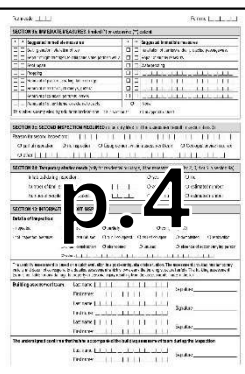
Table 2: The BDU form and its 11 sections

<p>p.1</p>	<p>Section 0: Inspection identification Section 1: Building identification Section 2: Building description</p>		
<p>p.3</p>	<p>Section 3: Structure typology & Seismic vulnerability Section 4: Structural damage & residual seismic capacity Section 5: Damage to non-structural elements</p>		
<p>p.2</p>	<p>Section 6: External dangers Section 7: Subsoil and foundations Section 8: Summary of sections 3-7 Section 9 a): Usability assessment 9 b): Immediate measures</p>		
<p>p.4</p>	<p>9 c): Second inspection required 9 d): Temporary shelter needs Section 10: Information about inspection</p>		
<p>p.5</p>	<p>Section 11: Additional comments, sketches and/or records</p>

The BDU form is composed of the following eleven sections on five pages (see annex 2):

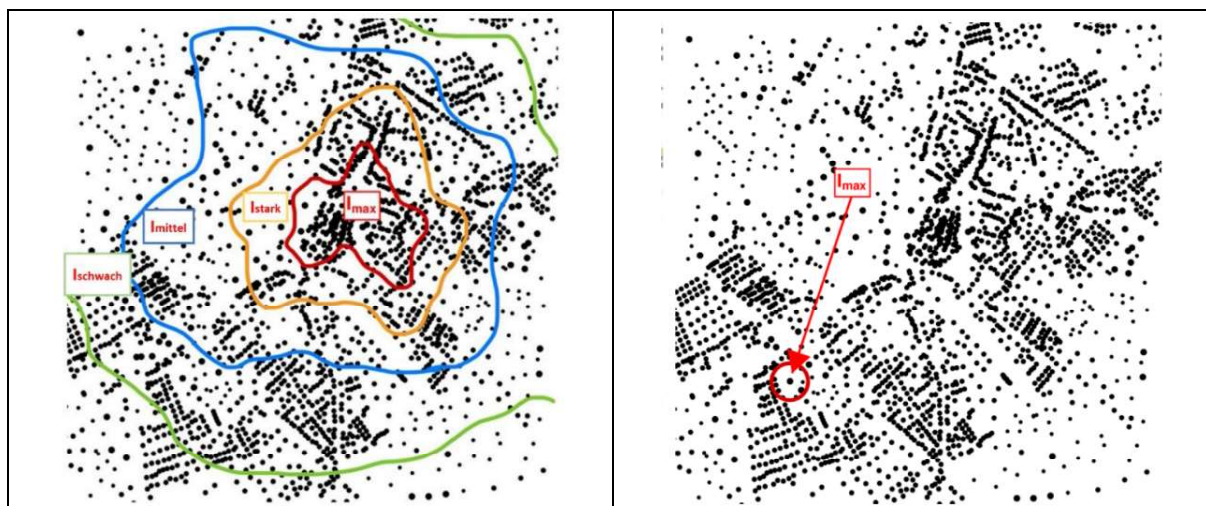
Fig. 3. Left: the intensities recorded after the main shock; Right: the displacement of the epicentre [9]

More precisely, it is necessary to consider a potential migration of the main shock epicenter towards the location of the building to be assessed. Ideally, it would be helpful to also consider possible local effects, such as amplification due to the presence of soft soil, for example, but in the absence of reliable information on this subject, it is logical to consider the maximum intensity of the main shock as it is. In this regard, it should be noted that a guided tour of the epicentral zone (of the main shock) is essential for the inspection teams so that the experts can see for themselves the type and level of damage in the epicentral zone.

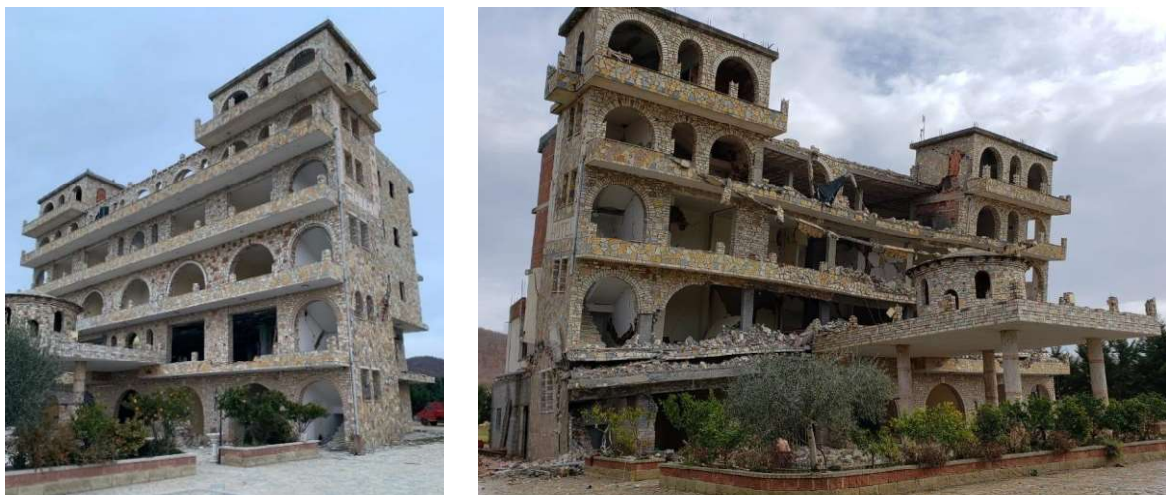
Fig. 6. Left: Damaged building after the Nov. 26, 2019, earthquake in Durrës. Right: same building, with increased damages due aftershock of Jan. 01, 2020 (photo F. Guni)

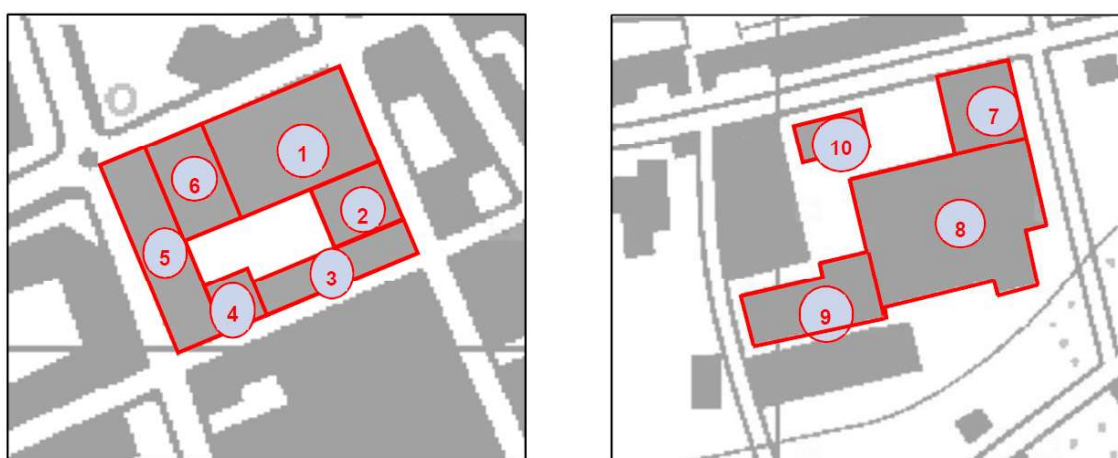
Fig. 10. Left: Example of a uniform urban block. Right: Example of fragmented urban complex

In the case of a uniform urban block (left figure), buildings 1 and 3 are corner buildings, buildings 2, 4, and 6 are row-in buildings, and building 5 is a row-end building.

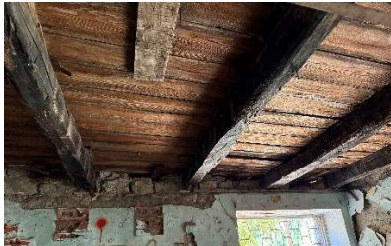
Fig. 14. Wooden flexible floor

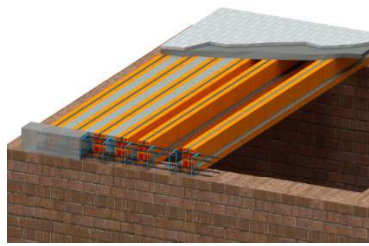
Fig. 15. Floor with prefabricated reinforced hollow clay tile beams with RC ring beams

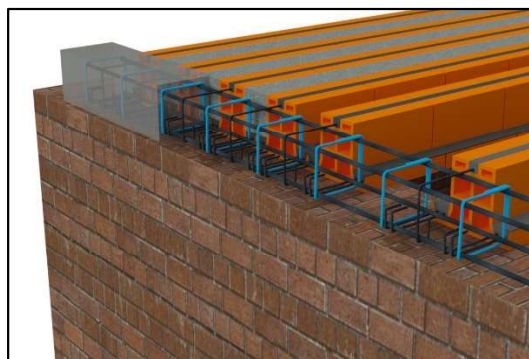
Fig. 18. Tie beams

Floors play a key role in ensuring the integrity of buildings. This integrity is a prerequisite for a global collapse mechanism, which rigid floors generally fulfill. For floors with a uniaxial load-bearing system and often insufficient connections to the walls, this integrity cannot always be guaranteed. In such cases, local collapse mechanisms cannot be excluded. Ring beams can significantly mitigate this issue and contribute to the overall structural integrity. These elements provide continuity and stiffness at each floor level, enabling the diaphragm to act as a rigid or semi-rigid element and distribute lateral forces uniformly to the vertical load-bearing walls.

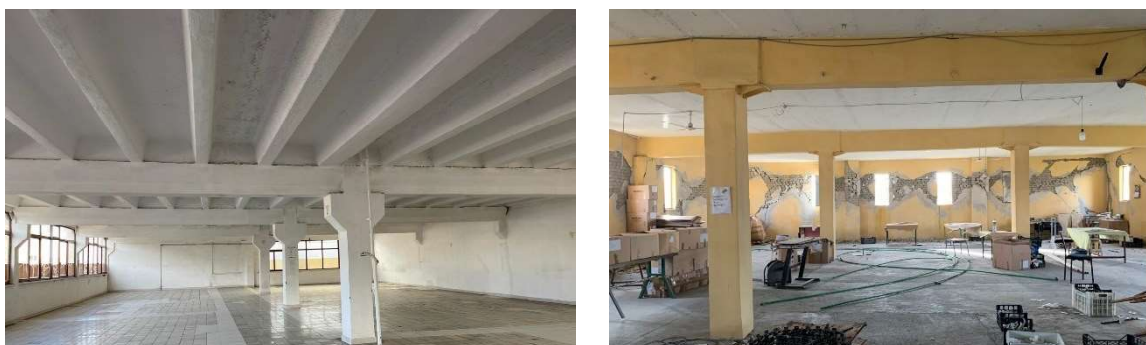
Fig. 19. RC frames in one direction. Left: with prefabricated element. Right: cast in place

Structures that have not been conceived to be earthquake-resistant can exhibit significant vulnerabilities, such as the lack of a lateral load resisting system in one or even two directions. Such weaknesses can also arise from renovation works if seismic safety was not considered during the modifications (structural interventions). Typical examples are met during interventions in existing masonry structures to create large openings in existing bearing walls. In Albania, there are a lot of buildings designed and implemented with lateral load resisting frames only in one direction joined together with prefabricated slab panels. In some cases, the frame itself is composed of prefabricated members (columns and beams).

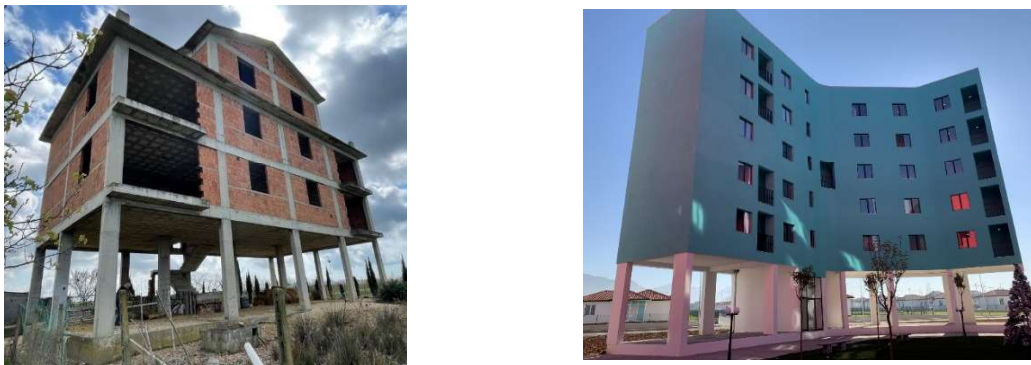
Fig. 22. Existing buildings with irregularities in elevation – soft storey

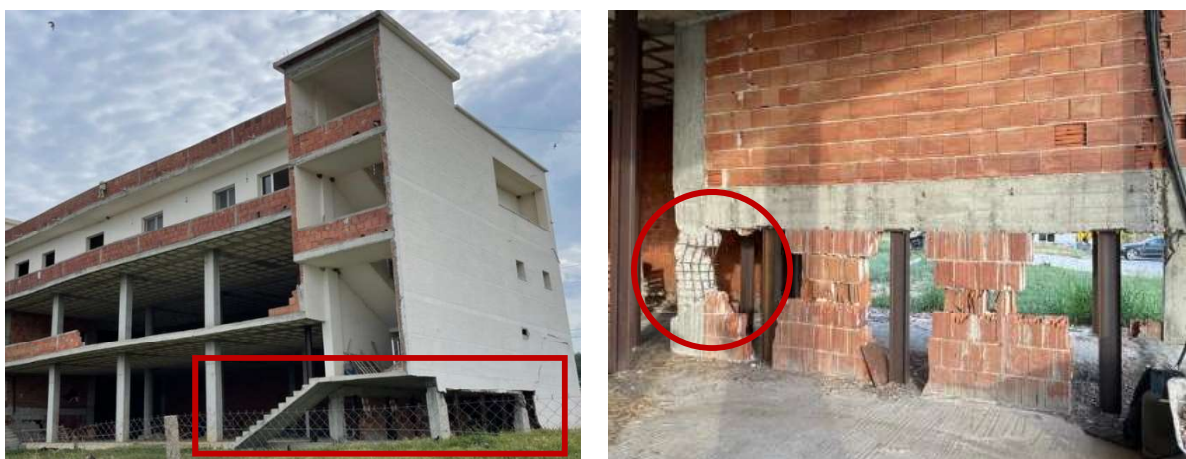
Fig. 27. Short column due to beam of stair landing

- Short columns that are foreseen with a reduced length due to steep terrain or columns that are shortened by beams of stair landings, etc.
- Captive columns, when the height of column is “reduced” by the infill walls on both sides. Captive columns are often met in industrial or school buildings, but also in underground floors of buildings, where masonry infills are used to create openings, extending along whole span of the RC frame.

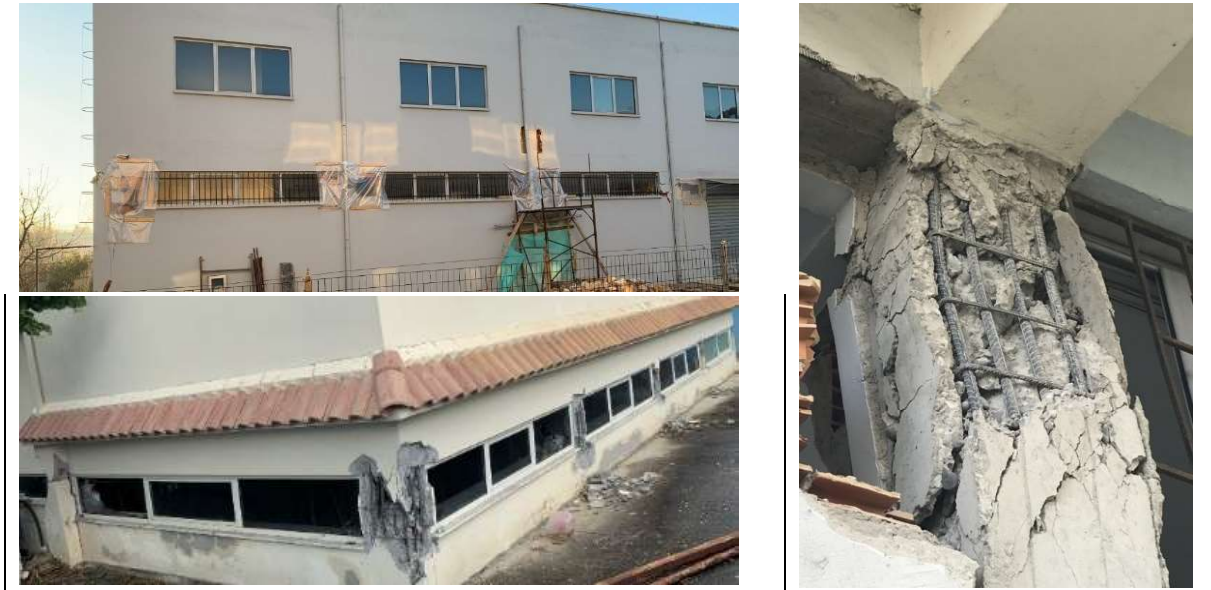
Fig. 28. Captive columns – damaged from Nov. 2019 earthquake

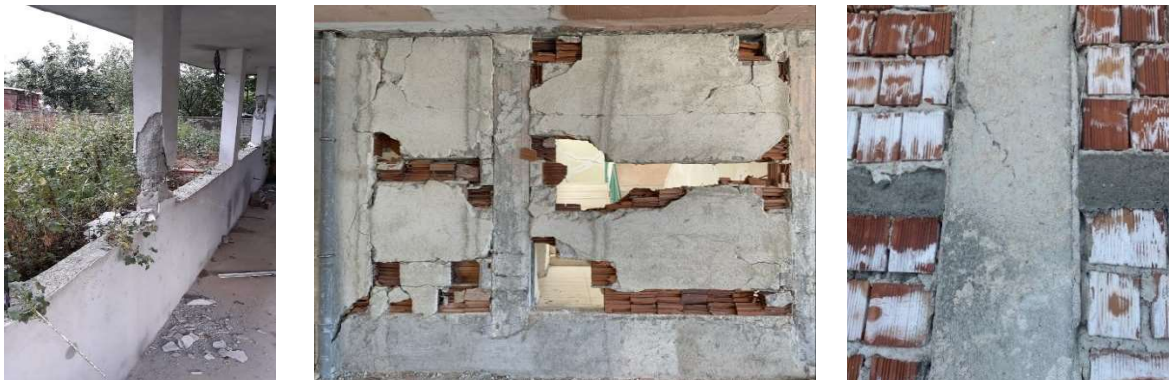
Fig. 29. Left: short column effect. Middle and right: Inappropriate connection RC frame - Tie beam

In this context, special attention is needed also for parapets or tie-beams, that if not properly implemented, can create conditions for generating “short column” phenomenon, so causing serious damages during earthquake events.

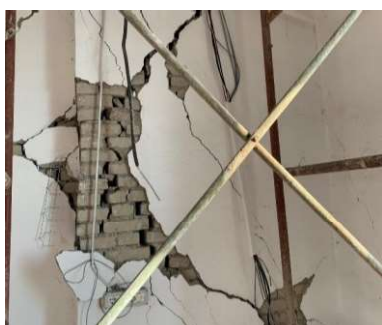
Fig. 30. Cracks in silicate brick masonry showing weak brick-mortar bond

- **Poor mortar quality:** This issue is mostly observed in masonry buildings constructed with silicate bricks, typically built through voluntary work before 1990, caused mainly by weak brick-mortar bond. The November 2019 earthquake revealed significant damage in this building typology (notably in the Kombinat area of Tirana), whereas in other areas, the same typology demonstrated good structural performance with minor damage.
- **Poor concrete quality:** This issue is evident in several reinforced concrete frame buildings, where the concrete class is significantly lower than those specified in the technical codes and standards (KTP and KTZ) in force, at the time of construction.

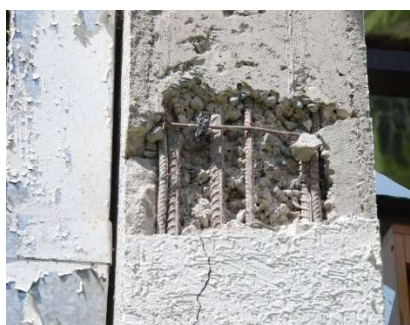
Fig. 31. Low quality of concrete in RC structures

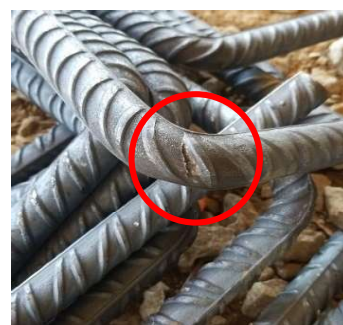
Fig. 32. Cracks in steel rebars

Special attention should also be paid to the ductile properties of steel rebars. The following example illustrates cracks formed during the bending of the bars on site.

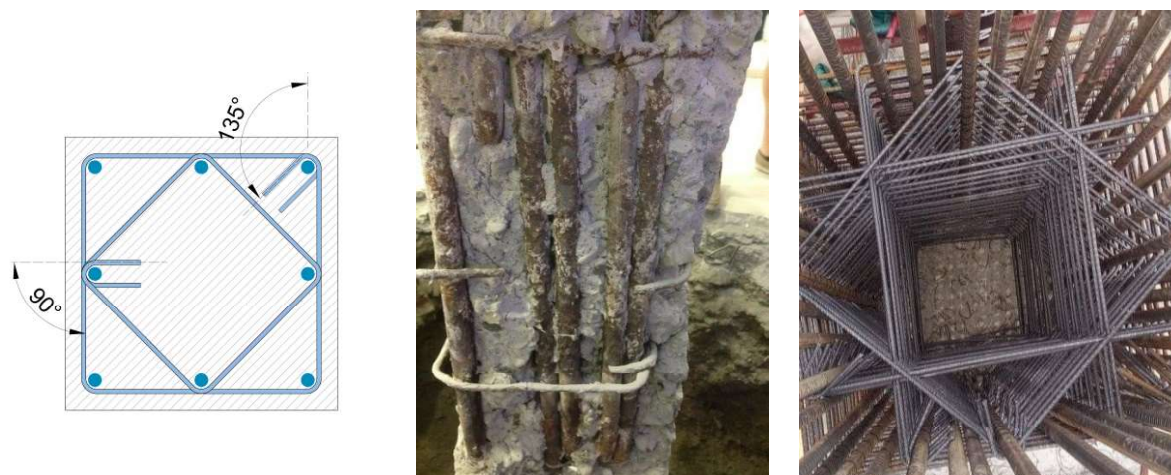
Fig. 34. Left: Closed hoop stirrups as required by KTZ 10/1-1978. Middle: Poor detailing of stirrups. Right: Properly closed hoop stirrups.

- **Closed hoop stirrups:** In many reinforced concrete buildings, assessed after the November 2019 earthquake, it was observed that properly closed hoop stirrups are missing and so, not ensuring adequate concrete confinement, despite specific requirements of KTZ 10/1-1978.

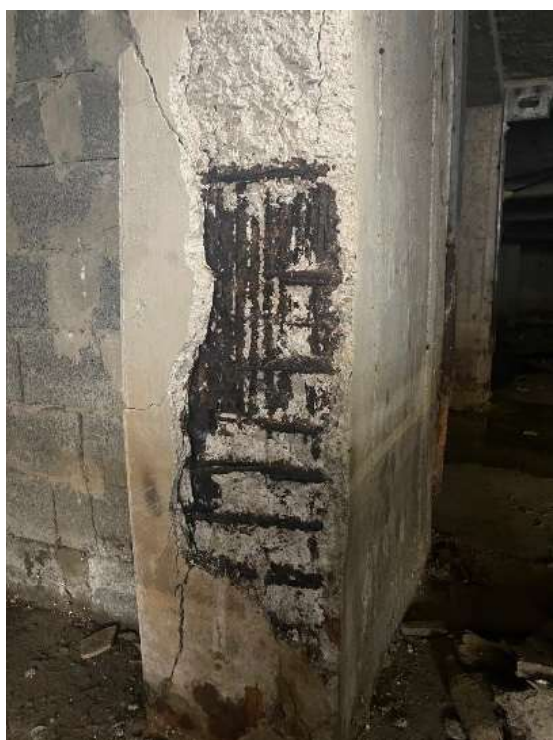
Fig. 36. Example of RC element with rusted and corroded rebars

Typical pre-existing damages are characterized by rusted and corroded rebars. Pre-existing cracks can often be identified by the dark colored dust inside.

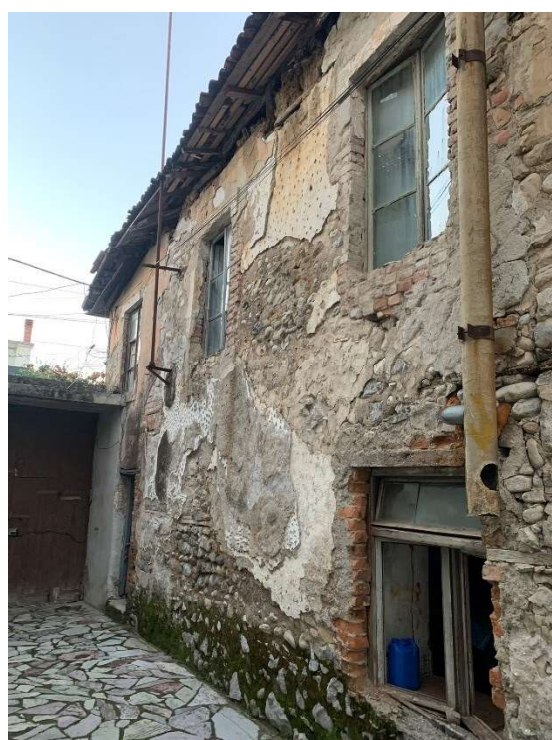
Fig. 37. Example of building with damage due to lack of maintenance

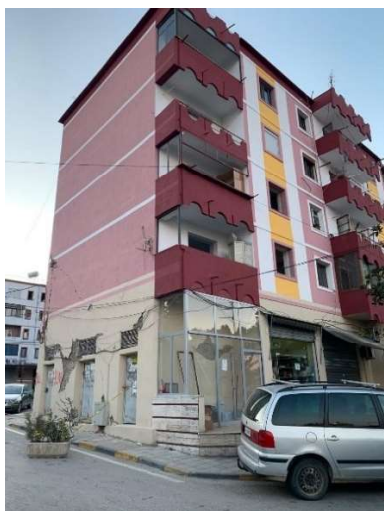
Fig. 39. Ground floor intervention in masonry buildings

- Interventions in ground floor of residential buildings to make them more accessible for business purposes – partial openings of the basement, replacement of windows with doors or even more large openings.
- Lateral interventions (in all storeys) to join existing building with side extension ones – depending on the side extension volume, structural interventions consist in replacement of windows with doors or even more large openings.
- Lateral interventions (casual) to join a room with a balcony – usually large openings to join totally one room of the apartment with the 'closed' balcony.

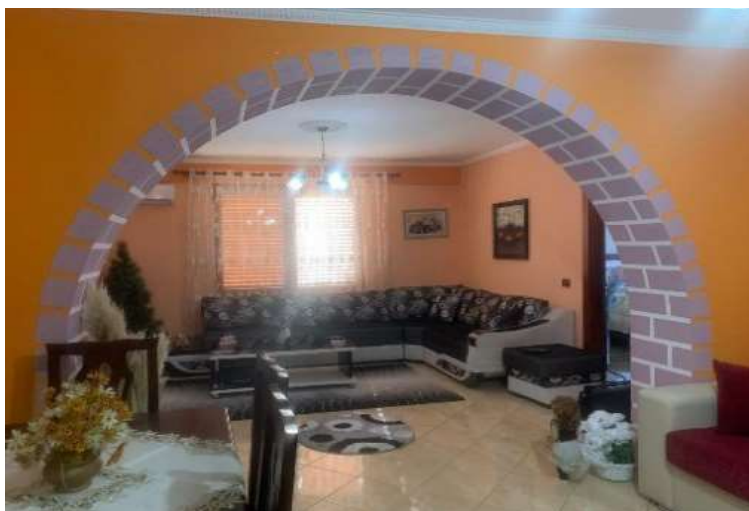
Fig. 40. Opening in a structural wall

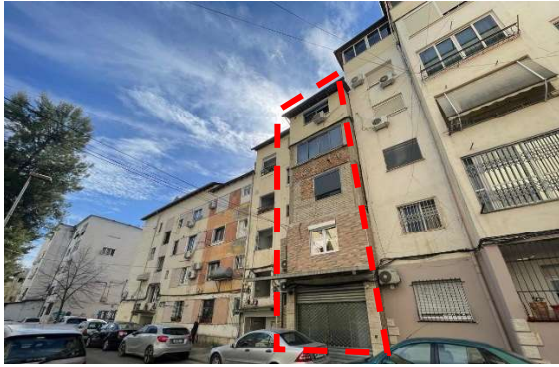
Fig. 41. Extension between 2 existing buildings

- Pounding effects between the existing unit and the lateral extension - in most cases, seismic joints are either non-existent or insufficient.
- Potential damage to the foundations of the existing building caused by the nearby foundations of the extension.
- Risk of differential settlement and structural damage due to increased stress from the additional weight of the lateral extension unit.

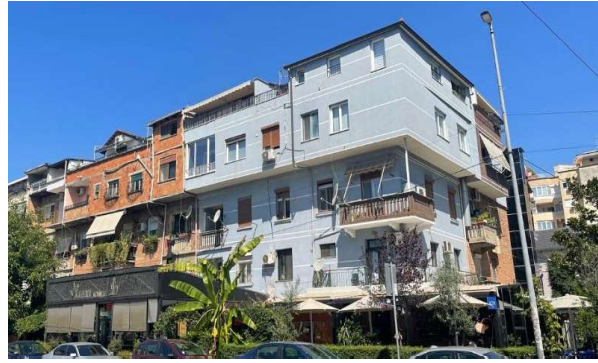
Fig. 42. Example of roof top extensions

Added floors, except increasing the mass of the building, change the dynamic characteristics (increase the base-shear force and the total overturning moment). In addition, local damage phenomena may also occur due to inappropriate connections between the existing building and the added floors.

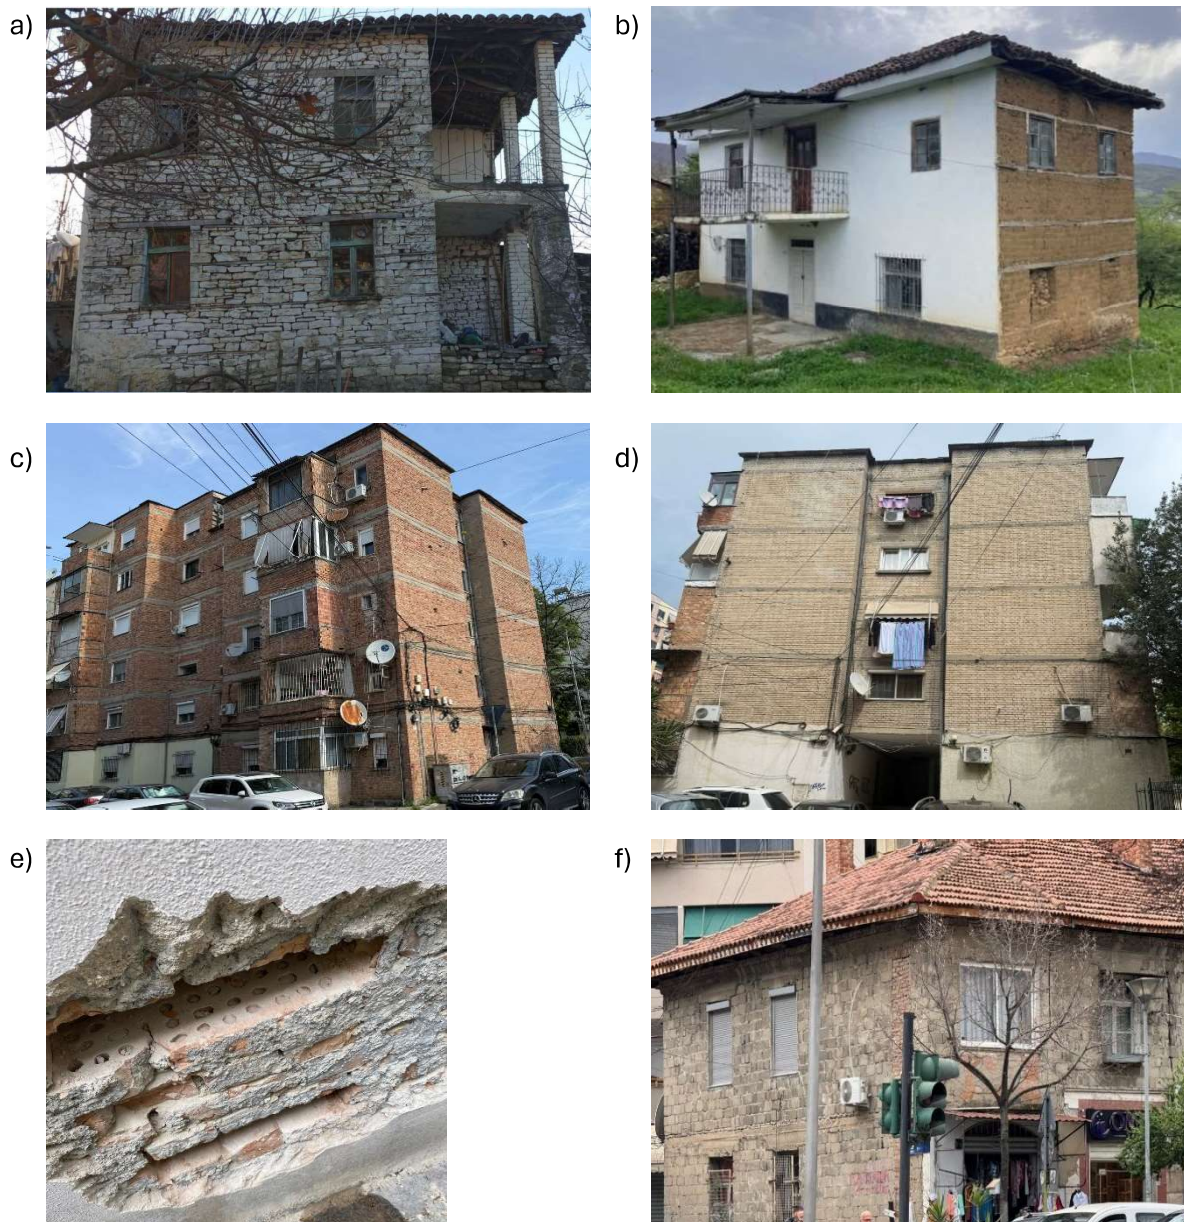
Fig. 44. Masonry buildings with a) stone (regular), b) mud bricks, c) clay bricks, d) silicate bricks, e) hollow bricks, f) concrete blocks

For masonry buildings, the BDUA form requires identifying the constituent unit of the masonry, offering six options of the main types found in Albania's building stock: stone, mud brick, clay brick (red brick), silicate brick, hollow bricks and concrete blocks.

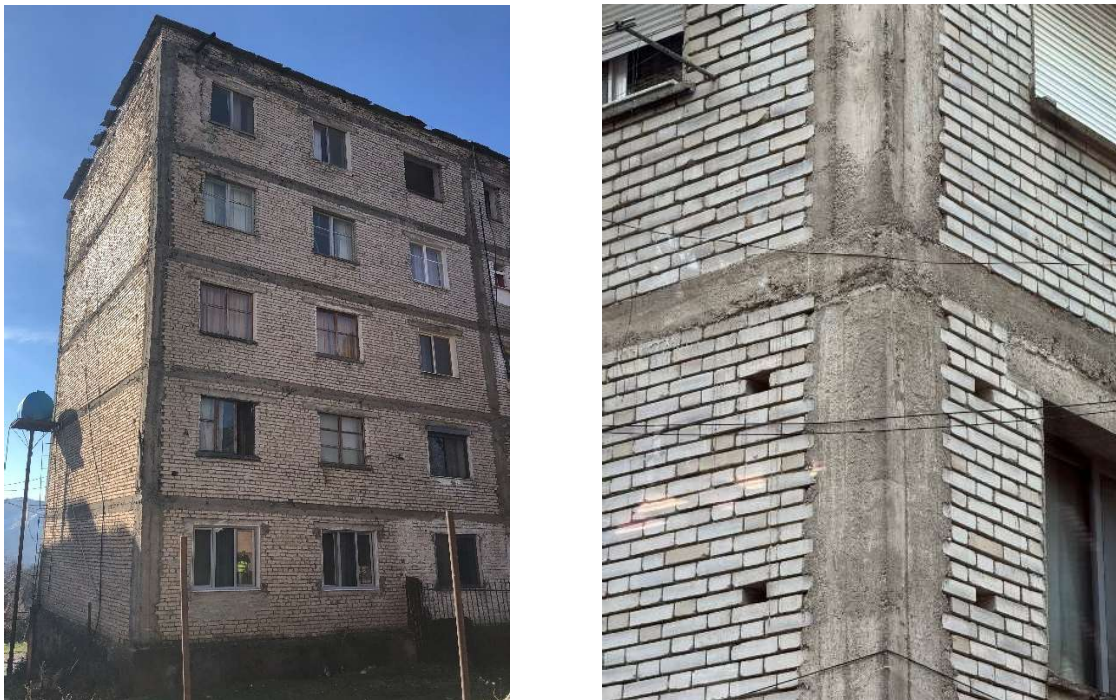
Fig. 45. Complex masonry buildings

For complex masonry buildings, it is important to assess the condition of the RC confining elements (columns and tie-beams) that frame the masonry and check the joined area (bond) between masonry and RC parts.

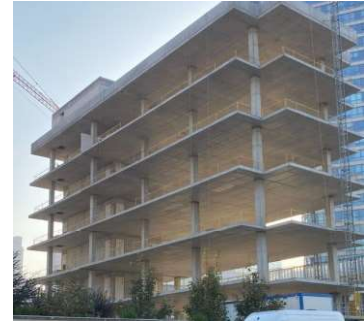
Fig. 51. Column supported slab system

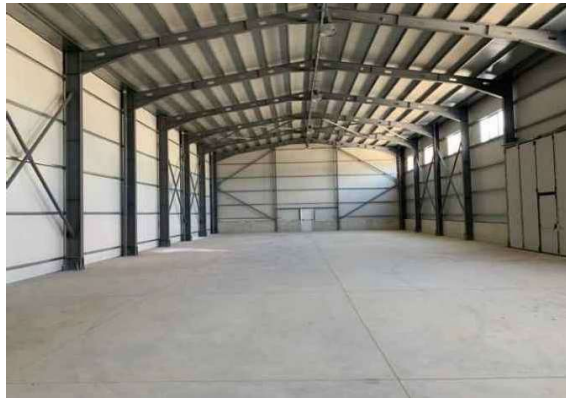
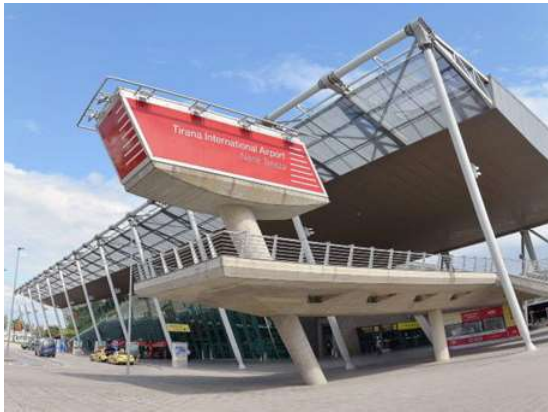
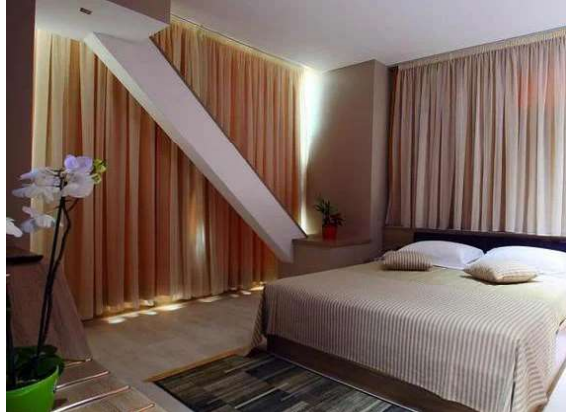
Fig. 52. Different examples of steel structure with bracing and steel frames.

Steel structures in Albania are used for large public or commercial buildings (airports, train/bus stations, stadium, large hypermarkets). This structure typology is also met in industrial buildings.

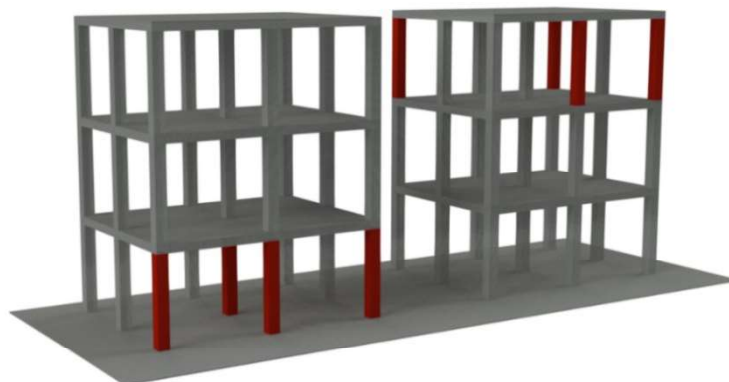
Fig. 55. Example of RC frames with same quantity of damaged structural elements but different residual seismic capacity

However, this quantitative criterion may, in certain cases, lead to a misinterpretation of the structure's overall residual seismic capacity. For example, the theoretical example below illustrates two reinforced concrete frames, each with four damaged columns (shown in red). Although the number of damaged elements is the same, their location within the structural system significantly influences the overall capacity. Without going into detailed calculations, it can be accepted that the first frame has a greater reduction in seismic capacity compared to the second one.

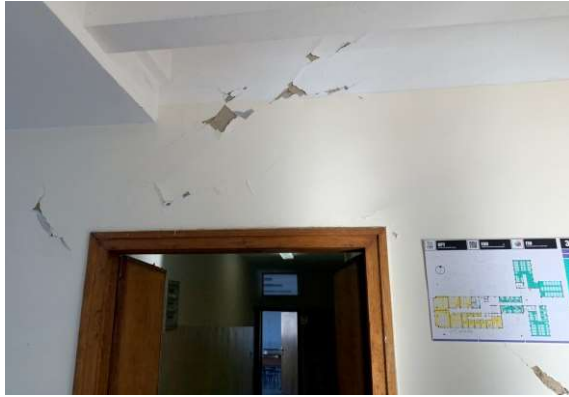
DL light: Shear cracks at the masonry spandrel

Fig. 56. Example of damage level in masonry walls

- ➔ **Light Damage:** Hairline or fine cracks in plaster or mortar joints; no cracks through the masonry units; no detachment or loss of material; no structural impact.
- ➔ **Moderate Damage:** Cracks along mortar joints and/or through individual masonry units; minor detachment of plaster; limited and localized spalling; the wall retains its structural function but shows early signs of degradation.

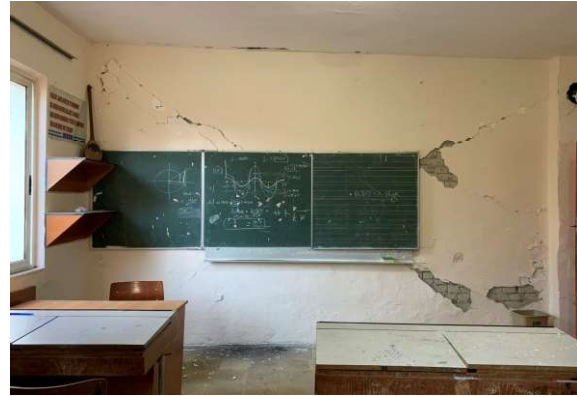
DL Moderate: Shear cracks at masonry wall

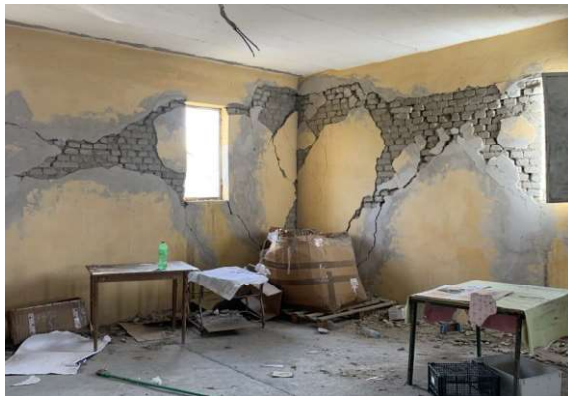
DL Severe: Large cracks at masonry wall

- ➔ **Severe Damage:** Wide cracks extending through masonry units and mortar joints; partial dislocation or loss of bricks/blocks; localized out-of-plane deformation or bulging; reduction in load-bearing capacity is evident.
- ➔ **Extreme Damage:** Large displacements, collapse of wall portions, or complete out-of-plane failure; widespread loss of units; wall stability is critically compromised; imminent risk of partial or total collapse.

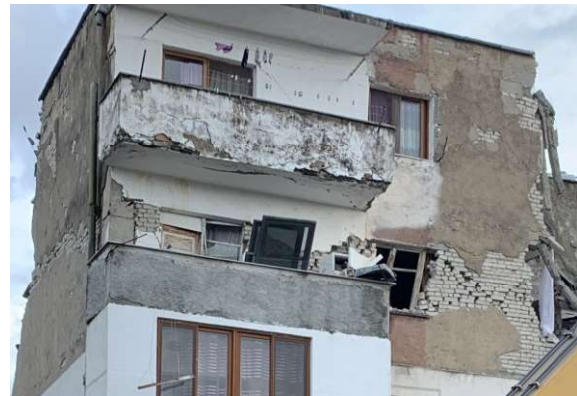
DL extreme: Masonry wall with large displacements

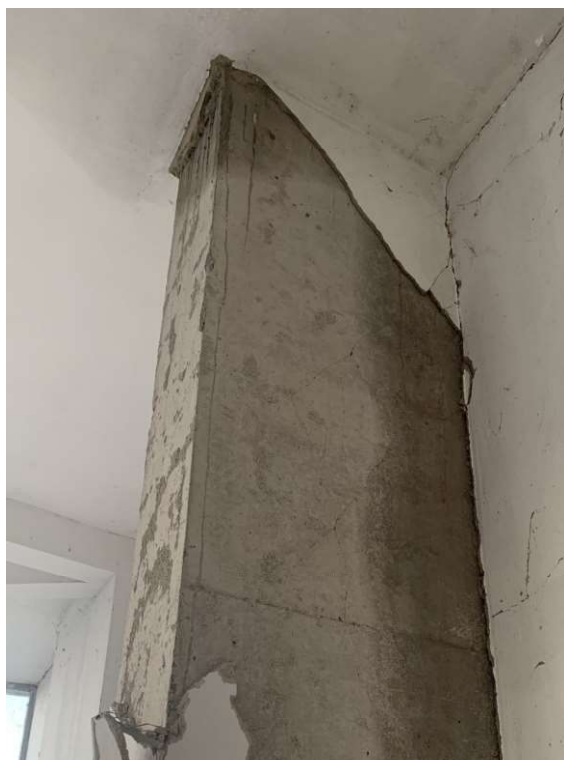
DL Light

- ➔ **Light Damage:** Presence of thin cracks without spalling; no visible reinforcement; no loss of section integrity.
- ➔ **Moderate Damage:** Well-defined cracks with initial signs of localized and superficial spalling; reinforcement remains covered; minor surface deterioration.
- ➔ **Severe Damage:** Concentrated wide cracks with significant concrete spalling; reinforcement bars are partially or fully visible; noticeable reduction in section stiffness.
- ➔ **Extreme Damage:** Rupture or buckling of reinforcement bars; extensive disintegration of concrete core within the reinforcement cage; structural integrity of the column is compromised. For elements with brittle behavior is common to distinguish light and extreme damage.

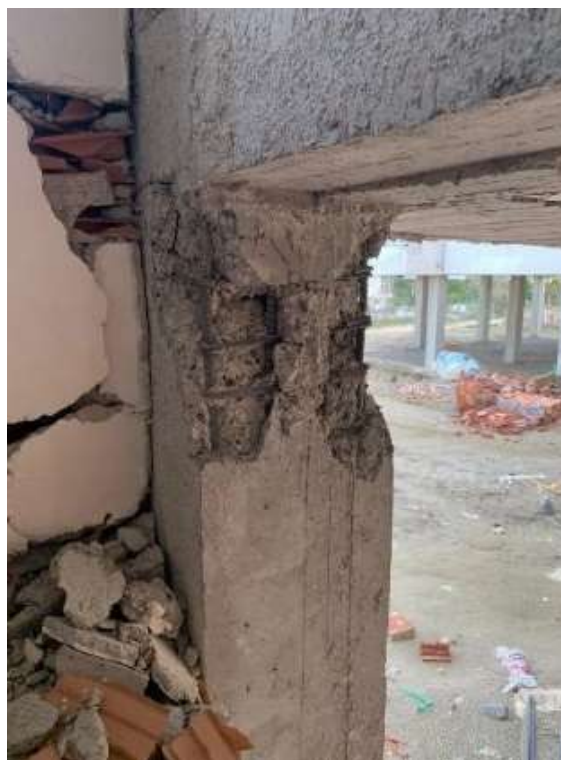
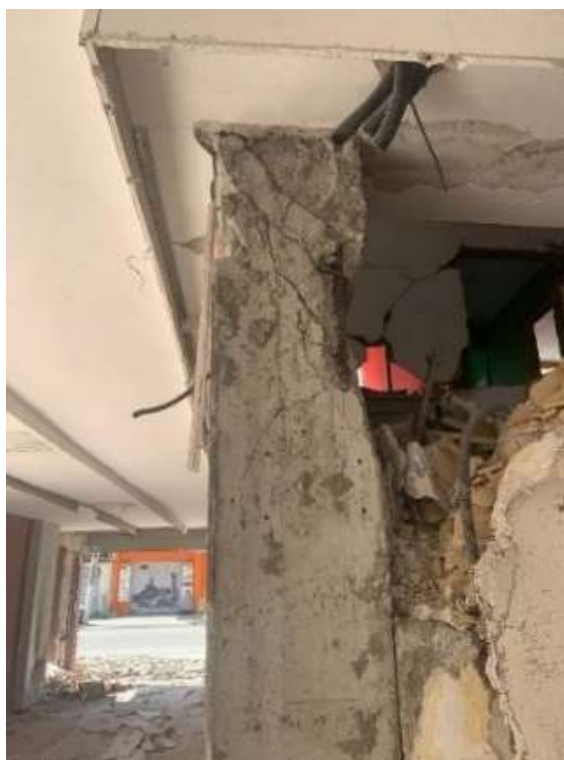
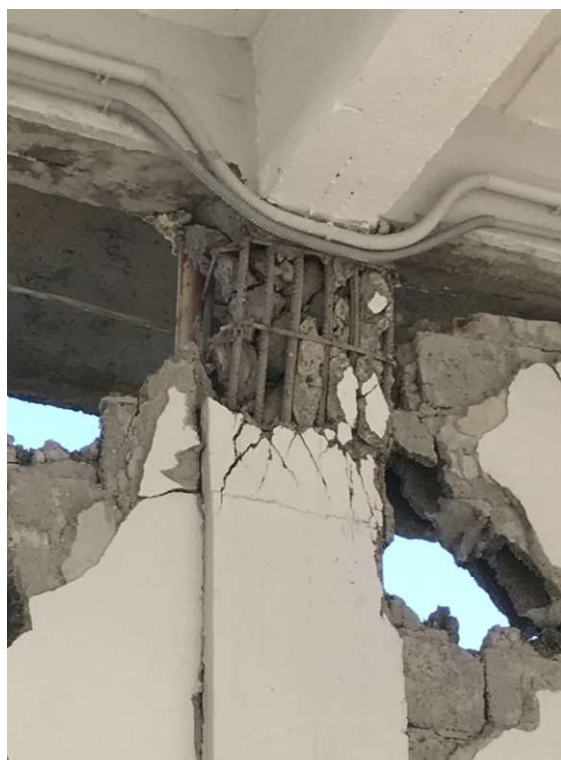
Fig. 57. Example damage level in reinforced concrete columns

DL Moderate

DL Severe

DL extreme

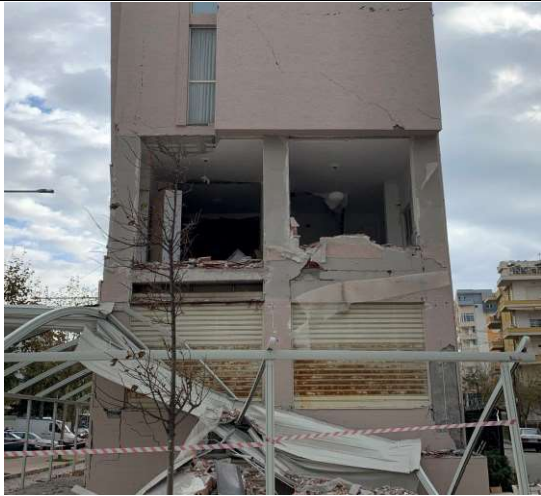
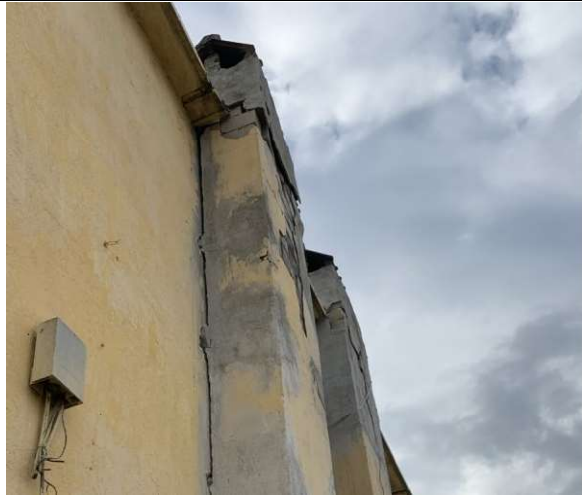
Infill wall out of plane collapsed. The danger could be eliminated by removing the walls	Damage of the chimney. The danger could be eliminated by demolishing & removing the chimney

The usability of buildings is often impaired by damage to secondary elements. However, the hazards they pose can often be eliminated by simple and quick measures. The recommended measures must be described in Section 9b. In many cases, removal of the damaged component can be an effective measure. Other possible measures are mentioned in Section 9b. Below are some examples of secondary components damage and the risk they pose.

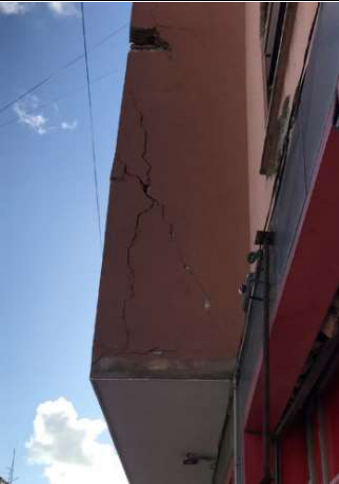
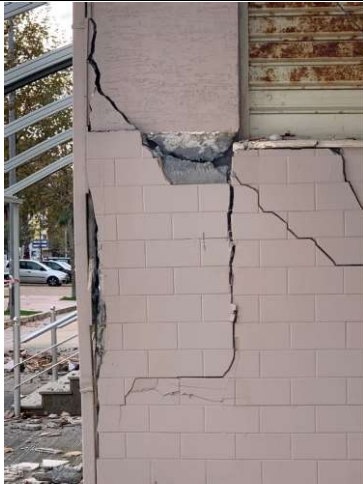
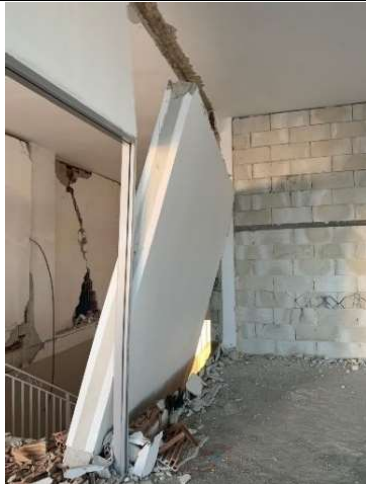
Facade walls at cantilever volumes. The danger could be eliminated by prohibiting the access below	Detachment of the plaster. The danger could be eliminated by removing the plaster	Collapse of the partition wall. The danger could be eliminated by demolishing & removing the walls

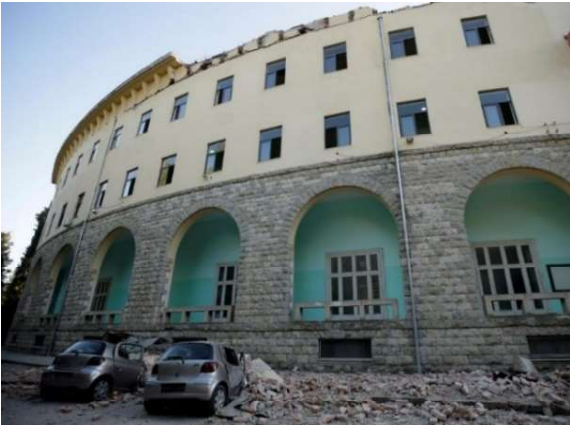
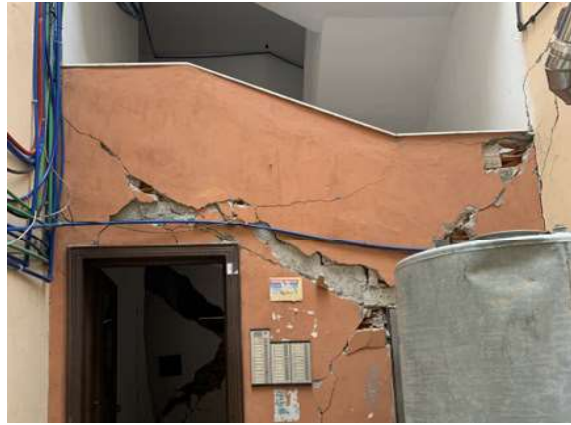
Fig. 59. Example of immediate measures for non-structural elements

Parapet collapse. Remove the parapet over the entrance and prohibit the access around	Damaged stairs. After verification correctly it can be decided to use the stairs and repair the concrete cover after or install wooden/steel stairs to access

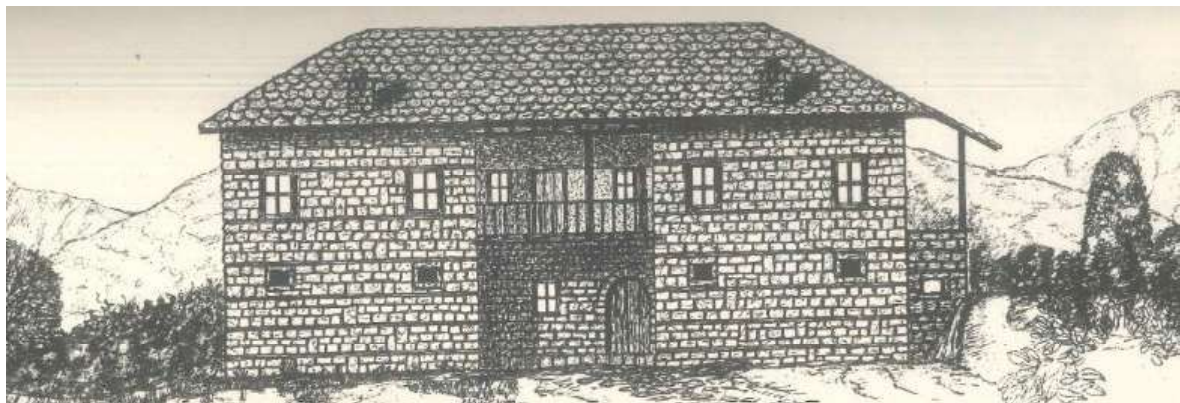
Sketches of housing units with stone masonry.
Source: P. Anastasi, "Nga thesari i arkitekturës sonë", 1984

Left: Housing unit with regular stone masonry and the use of wooden tie beams

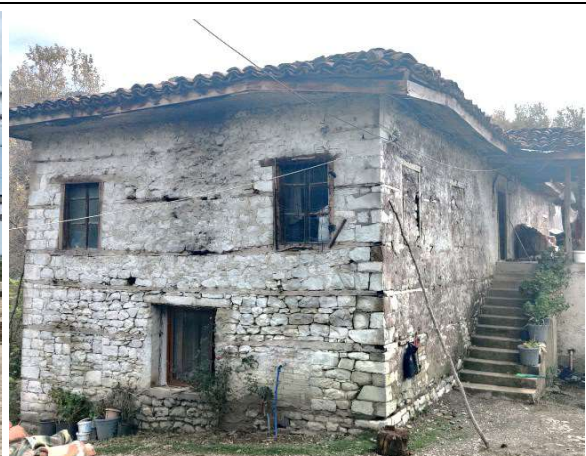
Right: Irregular stone masonry and corner reinforced with regular stones

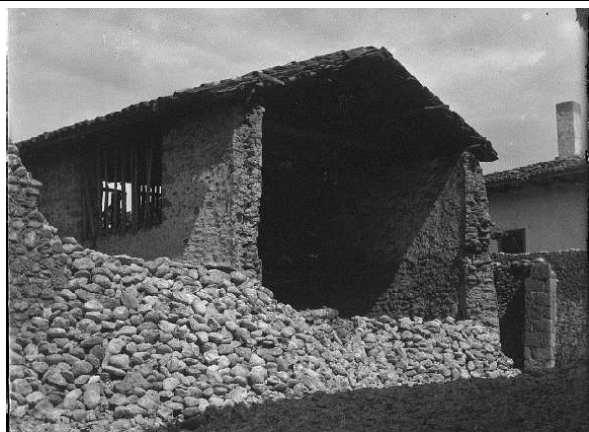
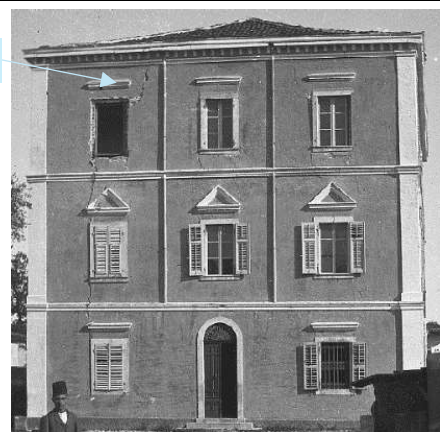
Examples from the June 1, 1905 earthquake in Shkodra (Source: Marubi)

Left: "**Out-of-plan failure**"

Right: "**Moderate shear-damage**"

Shear cracks

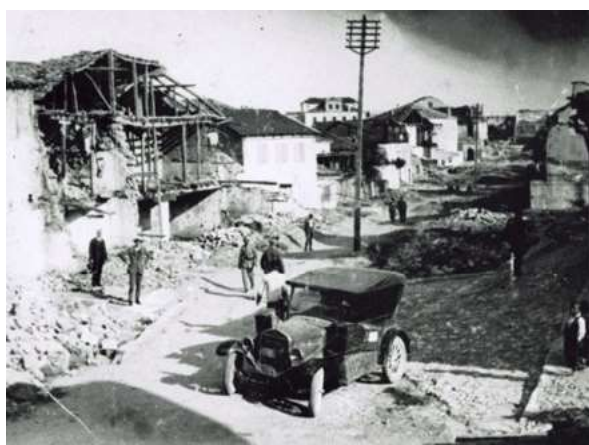
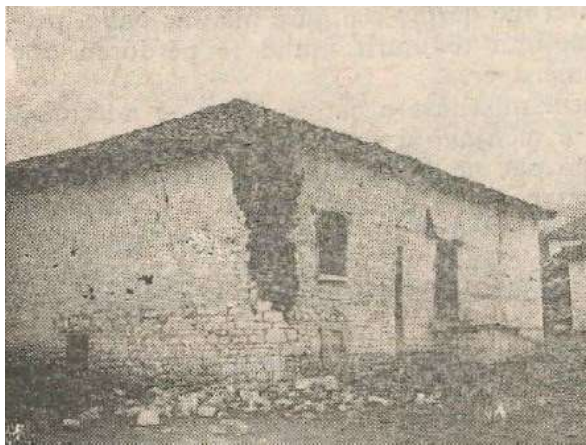
Left: December 17, 1926 earthquake in Durrës "**Out-of-plan failure**" (Source: Kosta Korçari, flickr.com)

Right: November 30, 1967 earthquake in Dibra "**Corner failure**" (Source: "Ndërtuesi" Journal, Volume 1, 1968)

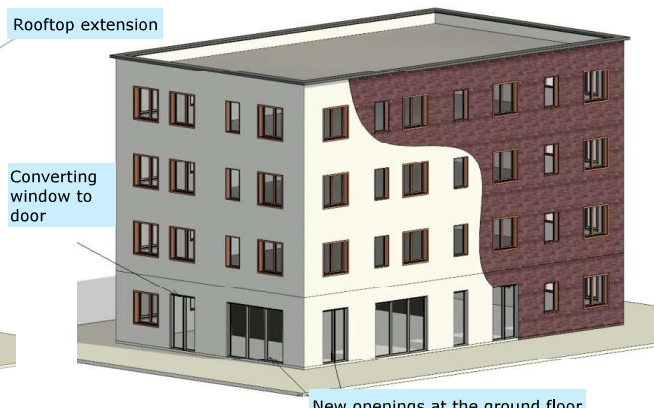
Left: Rooftop extension

Right: Ground floor openings

New openings at the ground floor

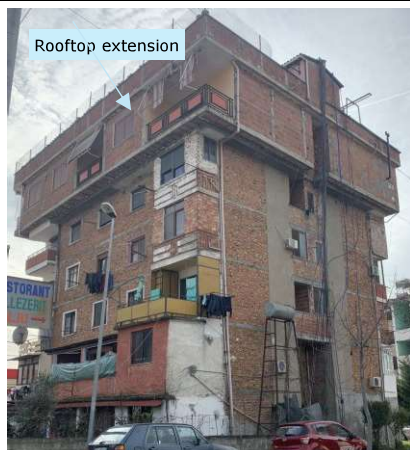
Rooftop extension

Interventions to the brick masonry buildings

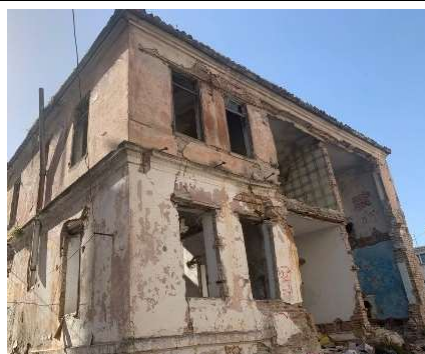
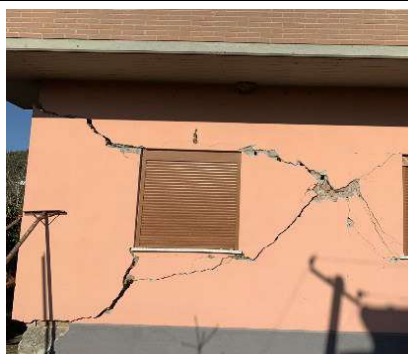
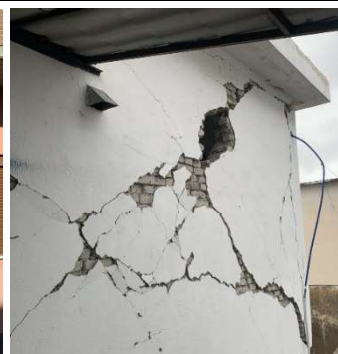
Left: Pier and spandrel shear cracks

Middle: Masonry pier failure at the GF masonry wall

Right: Partial collapse

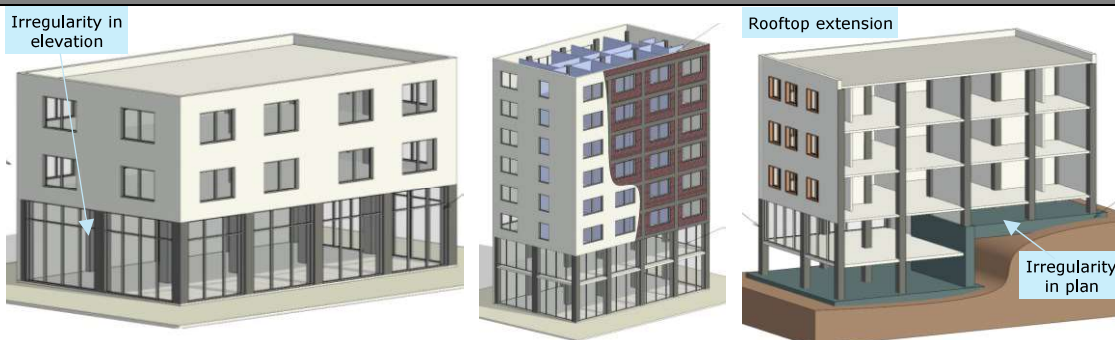
Sketches: RC-Frame buildings with concentrated flexibility at the GF, rooftop extension and irregularities due to stepped foundation

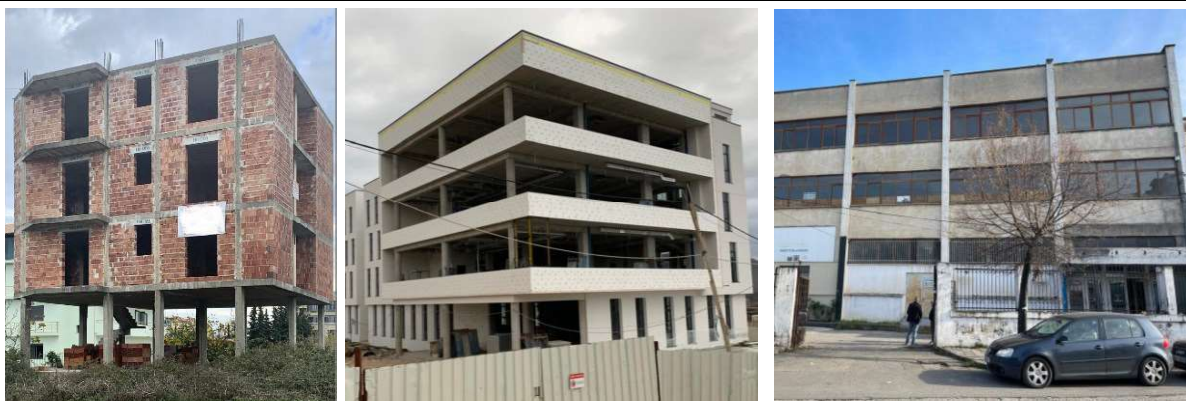
Typical mid-rise
RC frame building

Left: Similar to "flat slab system" with infills in the upper floors

Middle: "Strong columns-weak beams" system

Right: Planar frame system-industrial building
