Building Damage and Usability Assessment after earthquake (BDUA)

TECHNICAL MANUAL

TECHNICAL MANUAL
for the Building Damage and Usability Assessment (BDUA)
after earthquake

The **Technical Manual** is part of the technical framework to conduct and coordinate Building Damage and Usability Assessment (BDUA) services after an earthquake in Albania.

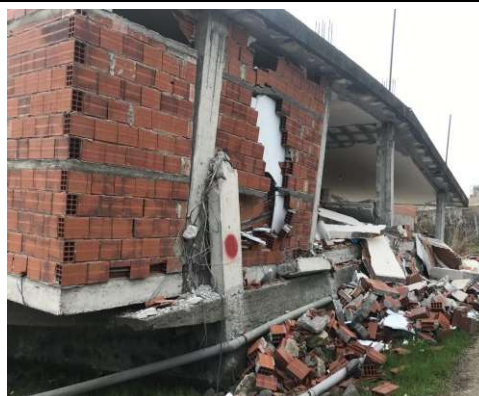
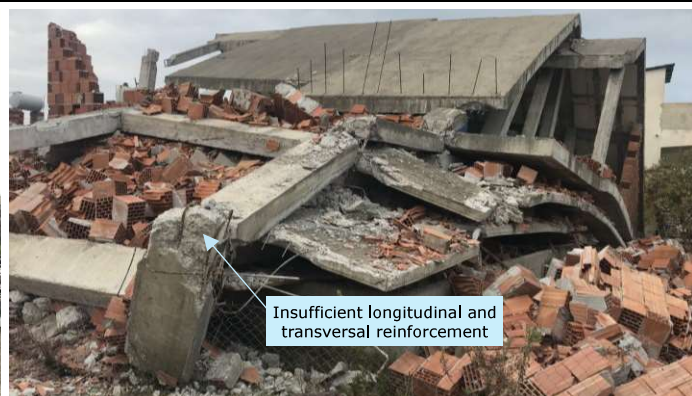
Left: Low-rise
building collapse
Soft storey
mechanism

Right: Mid-rise
building collapse
Pancake
mechanism

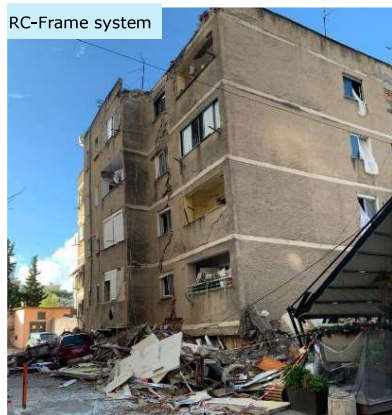
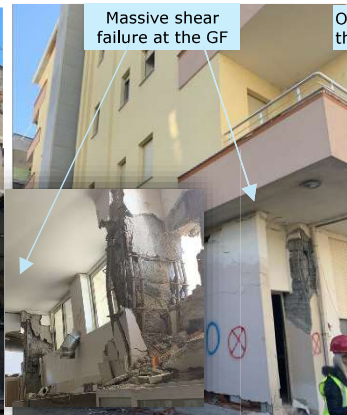
Damages to mid-
rise RC-Frame

Left: Soft storey
mechanism at
first floor

Middle: Shear
failure at the GF

Left: Shear failure
at the GF

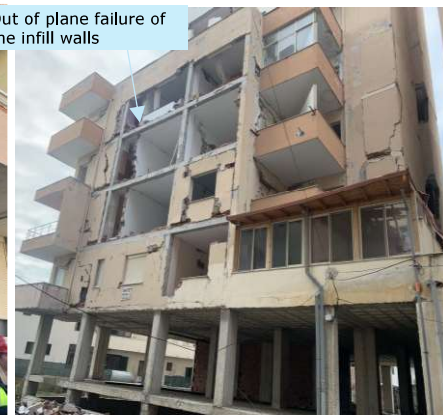
Out of plane failure of
the infill walls

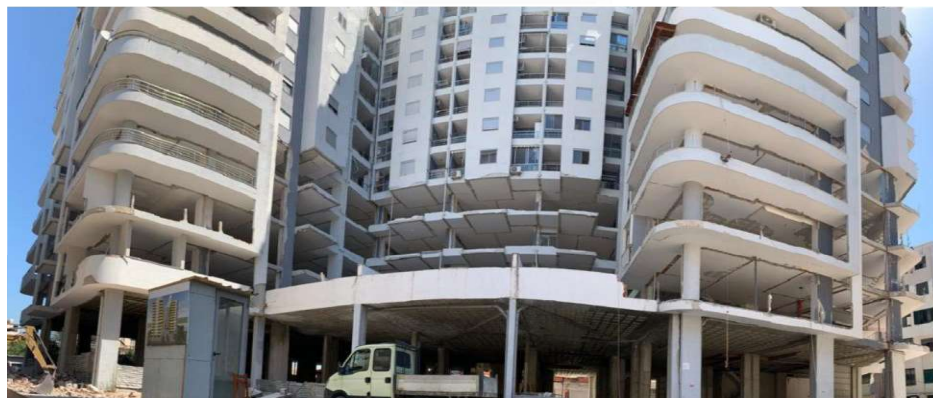
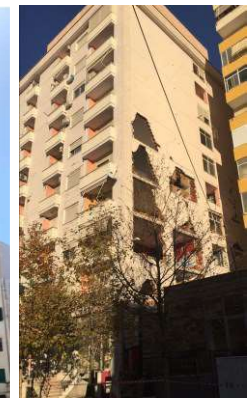
Damages to high-
rise RC-Frame

Left: Damages
due to high
flexibility

Right: Out of
plane failure

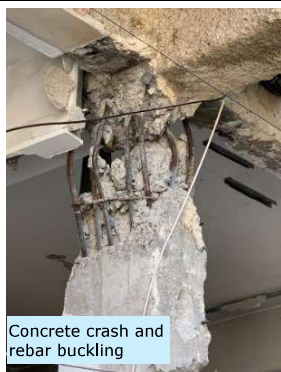
Lack or insufficient
hoop/tie details,
poor concrete,
added shear
effects

Concrete crash and
rebar buckling

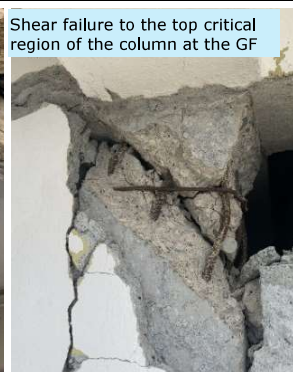
Shear failure to the top critical
region of the column at the GF

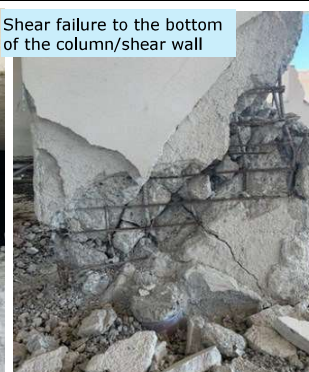
Shear failure to the bottom
of the column/shear wall

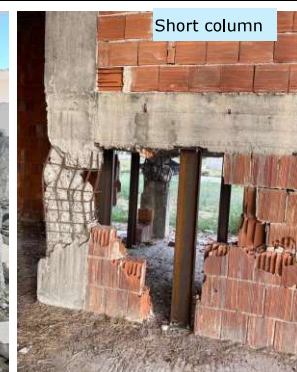
Short column

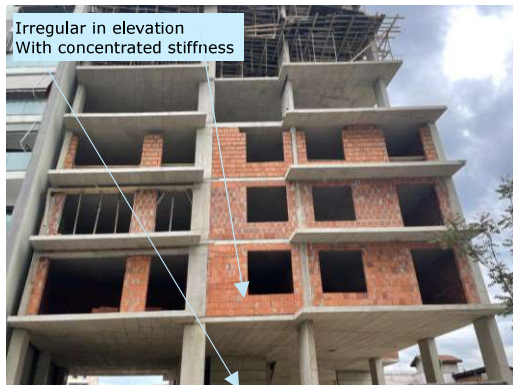
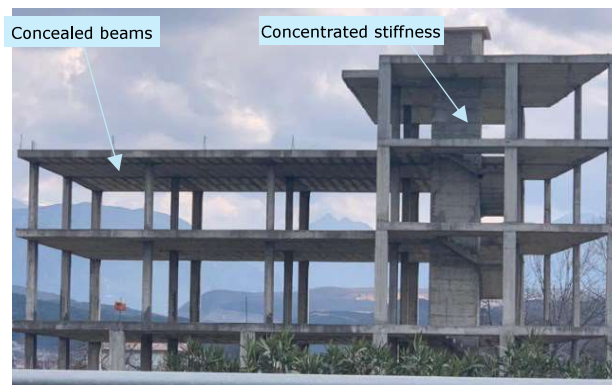
Sketches: Dual system buildings with irregularities in plan and in elevation

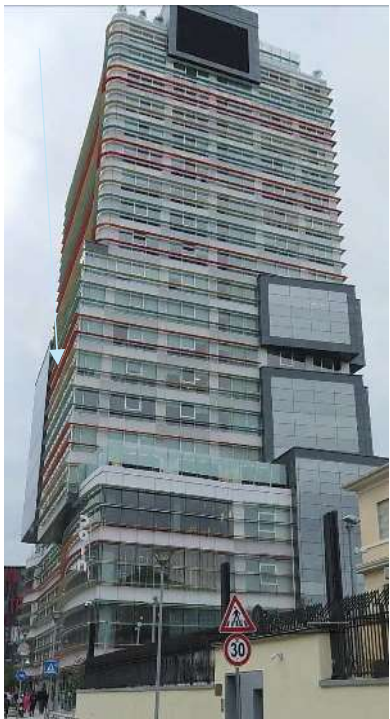
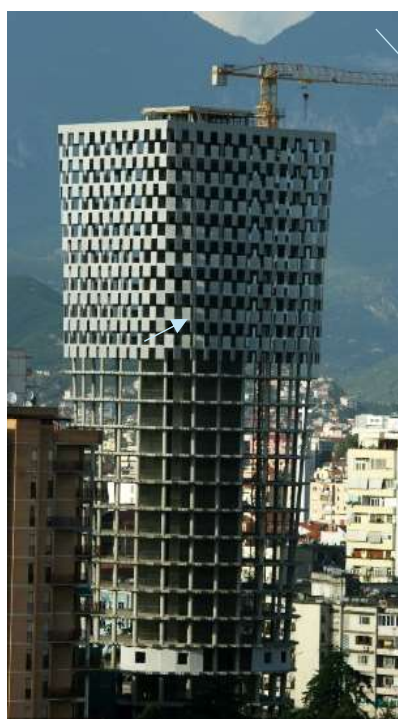
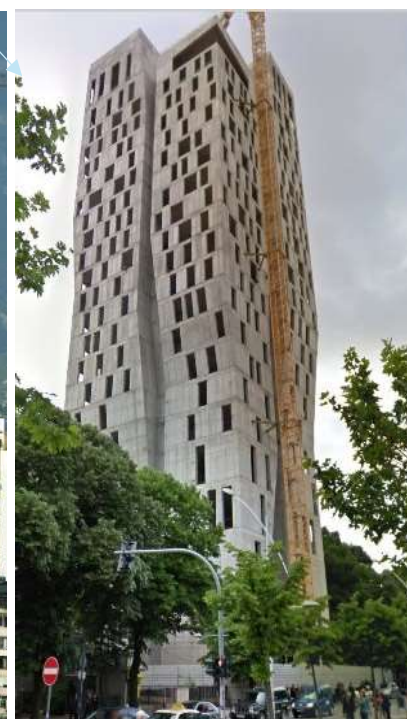
Some typical vulnerabilities to high-rise buildings

Left: Dual system

Middle: Core system

Right: Perimeter wall system

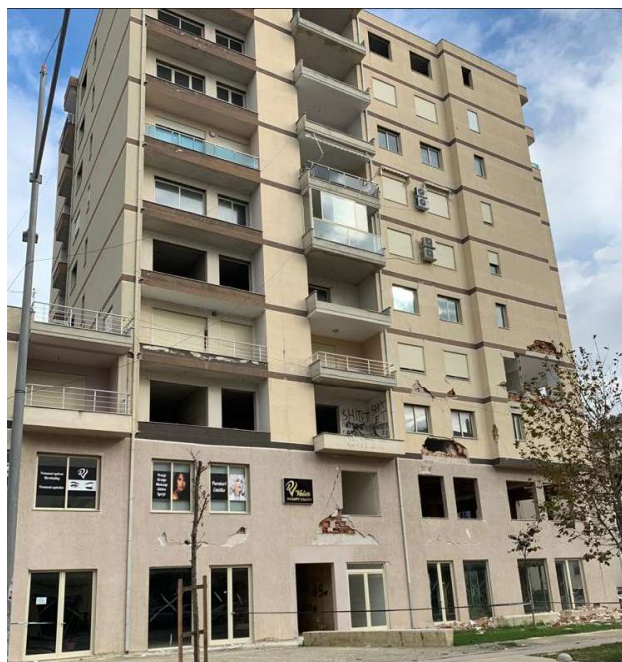
Photos from
Durrës November
26th, 2019 Eq.
Damages to mid-
and high-rise Dual
system

Left: Extensive
damage infills and
moderate damage
to shear walls and
columns at lower
floors

Right: Moderate
damages to infills

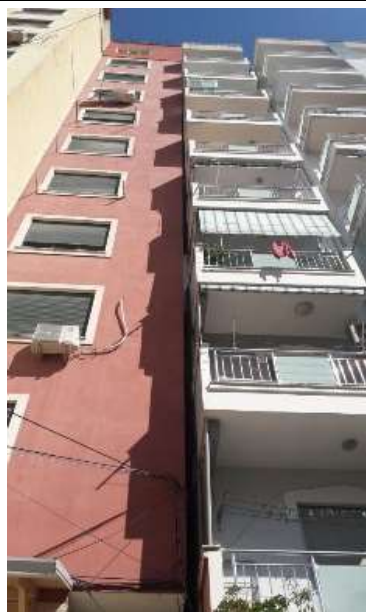
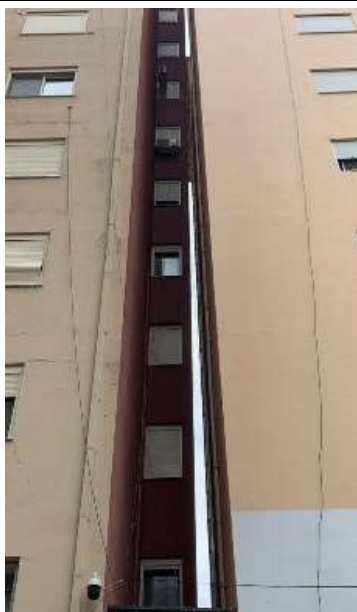
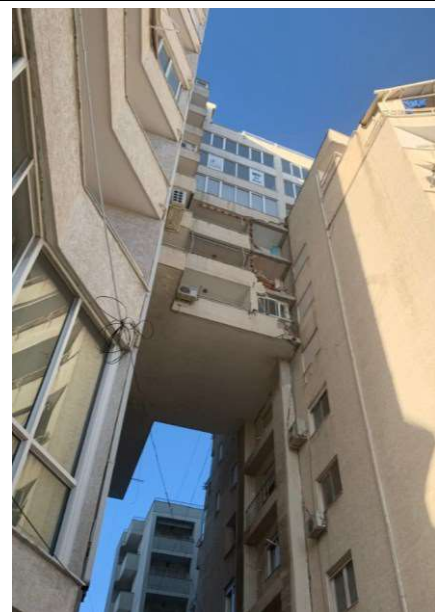
Other damages
observed to high-
rise Dual systems

Left and middle:
Differential
settlement and
building tilting –
few structural and
non-structural
damages

Right: Pounding
effect and Out of
plane failure of
infills

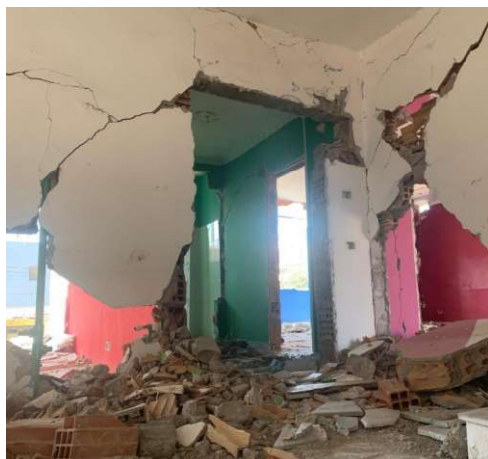
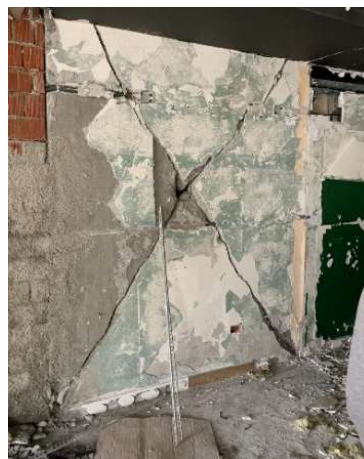
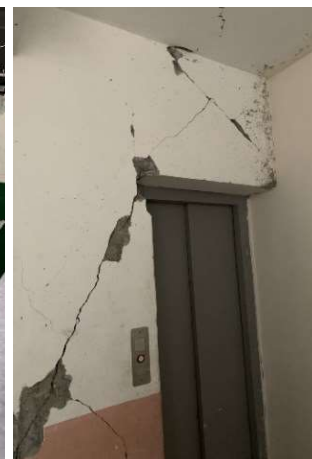
Most common
damages to Dual
systems,
especially to those
with low ratio of
shear walls

Left: damage and
failure of infills
and simple walls

Middle and Right:
Shear cracks at
shear walls

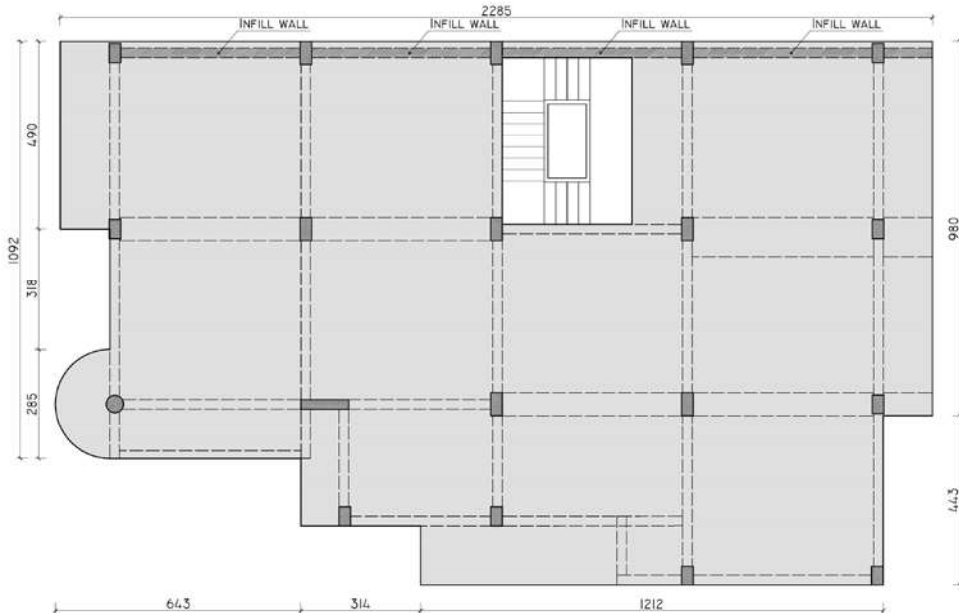
Building plan

<p>The floor plan shows a rectangular building with a semi-circular extension on the left side. The overall dimensions are 1092 units by 1212 units. The plan includes a central staircase and several rooms. Dimensions for various sections are provided: 643, 314, 1212, 285, 318, 490, 986, and 1473. Labels include 'INFILL WALL' and '2285'.</p>

Vulnerability aspects	<ul style="list-style-type: none"> • Plan irregularity: The building's configuration and the arrangement of its primary vertical structural elements indicate irregularity in plan. • Elevation irregularity: The story height of the ground floor is 4.0 m, so 30% larger compared to the upper floors height (3.06 m), fact that show elevation irregularity of the structural system. • Nonuniform distribution of infill walls: On the ground floor, only one of the external frame has end-to-end infill masonry (shown on the plan) while the other frames, on the facade and inside, do not have infill walls. This distribution of infill walls further increases the irregularity in the plan of the structure. On the upper floors, infill walls are more present, with a uniform distribution and so this increased presence compared to the ground floor affects the elevation irregularity of the building. Thus, leading to increased vulnerability due to torsion and promoting “soft storey” behavior. • The application of decorative reinforced concrete arches attached to structural columns on the ground floor affects their seismic performance by shifting the critical zones (regions) where the stirrup step is greater and consequently the shear capacity is lower.

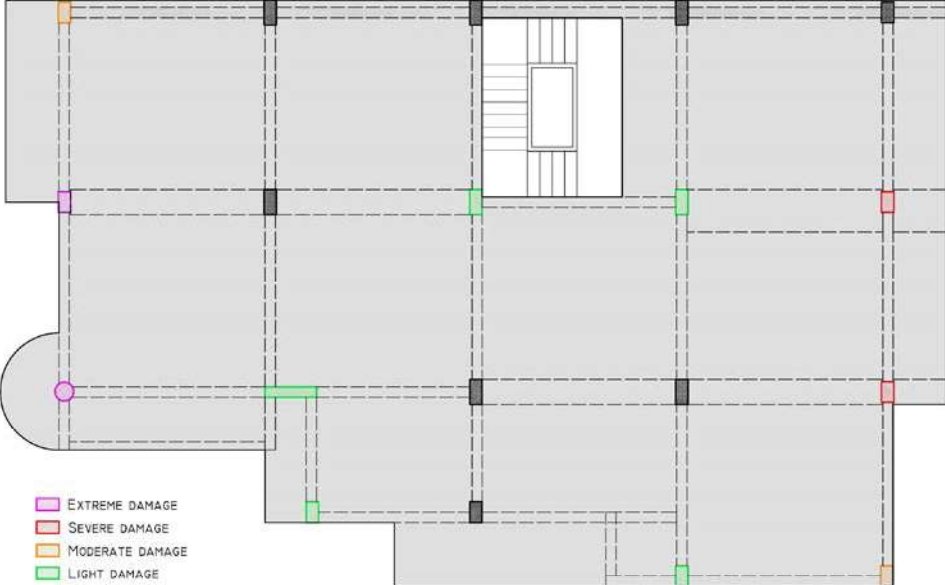
Observed structural damages	<p>In accordance with the BDUa assessment methodology - which prioritizes the identification of damage to structural elements as a basis for evaluating the residual seismic capacity of the building - the following data summarize the condition of the vertical primary seismic elements:</p> <p>No. of vertical primary seismic elements / storey: 19 Total no. of vertical primary seismic elements: 107 = (19x5 + 12)</p> <p>Observed damage to vertical primary seismic elements:</p> <ul style="list-style-type: none"> • light damage 5 elements • moderate damage 2 elements • severe damage 2 elements • extreme damage 2 elements <p>There were no damage clearly observed in the horizontal structural elements, including reinforced concrete slabs and beams.</p> <p>The floor plan below, illustrates the position of the damaged columns. Notably, all damaged elements are located on the ground floor, which plays a critical role in the global stability of the structure. Given the concentration and severity of the damage at this level, the seismic capacity of the building is classified as highly reduced in the BDUa form.</p>

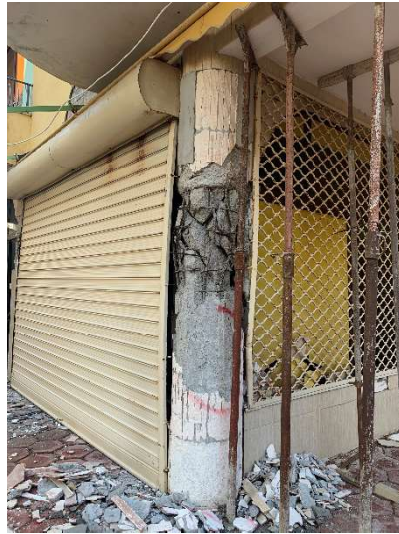
DL Extreme

The following photos, taken during the inspection of the building, show the structural damages associated with the damage level. Here are included also photos of damage to the infill walls (non-structural elements), but as referred to in the Technical Manual they affect the overall behavior of the structure under seismic action.

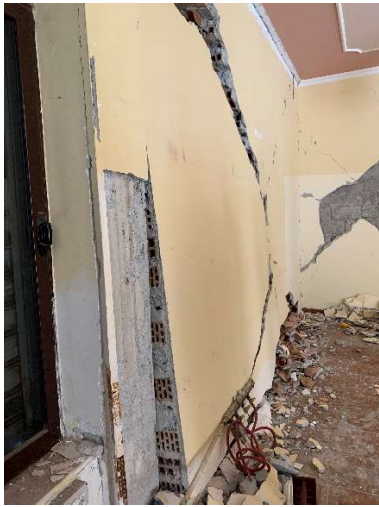
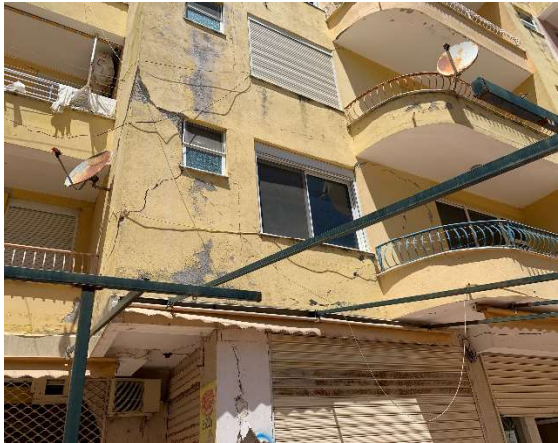
Photos of non-structural damages observed

During the inspection, the observed non-structural damages consist mainly in partition walls on the ground and the first floors. There were also some detached plaster on the facade of the building.

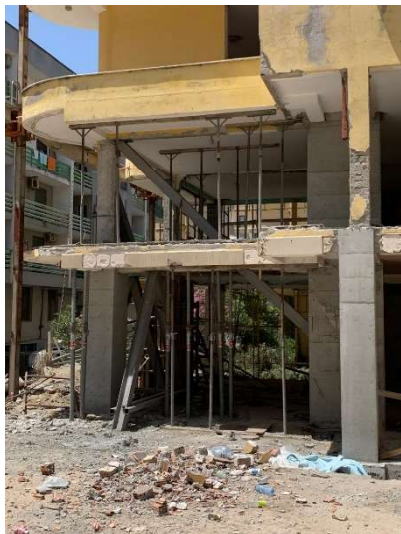
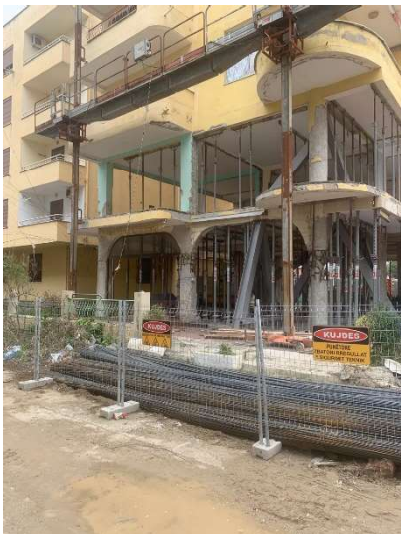
Immediate measures proposed by inspection team

Proposed immediate measure consist in:

- Removal of damaged infill and pertition walls
- Removal of plaster in the fasade
- Introduce a simple steel structure, till retrofit measures will be in place
